Aviation Investigation Preliminary Report

Location:	Harlan, KY	Accident Number:	ERA23FA048
Date & Time:	November 3, 2022, 10:09 Local	Registration:	N84R
Aircraft:	Beech A36	Injuries:	1 Fatal
Flight Conducted Under:	Part 91: General aviation - Personal

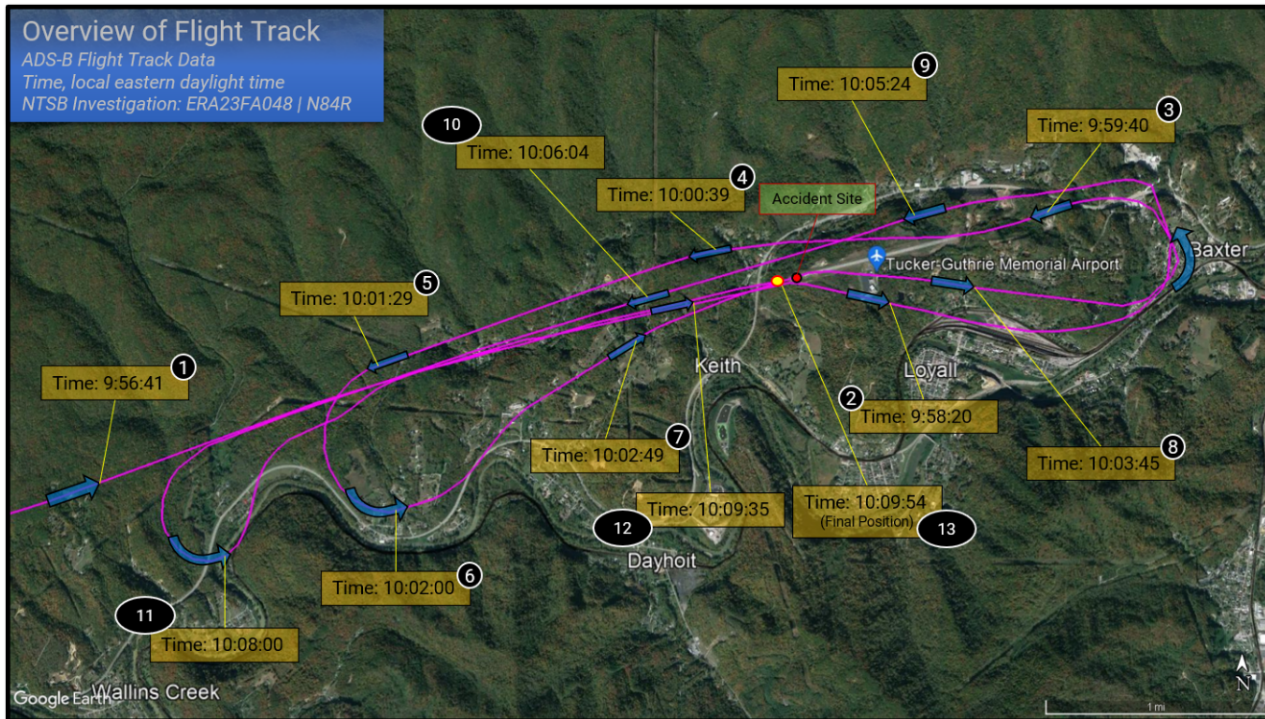
Review of archived audio recordings of the I35 common traffic advisory frequency from LiveATC.net found that as the pilot entered the traffic pattern area he stated, “Harlan tucker guthrie bonanza 84 romeo is two and a half to the west will circle for landing Harlan Tucker Guthrie.” There were no further radio communications recorded. Figure 1 depicts the ADS-B flight track recorded around the I35 traffic pattern.

Figure 1: Overview of the flight track around the I35 airport

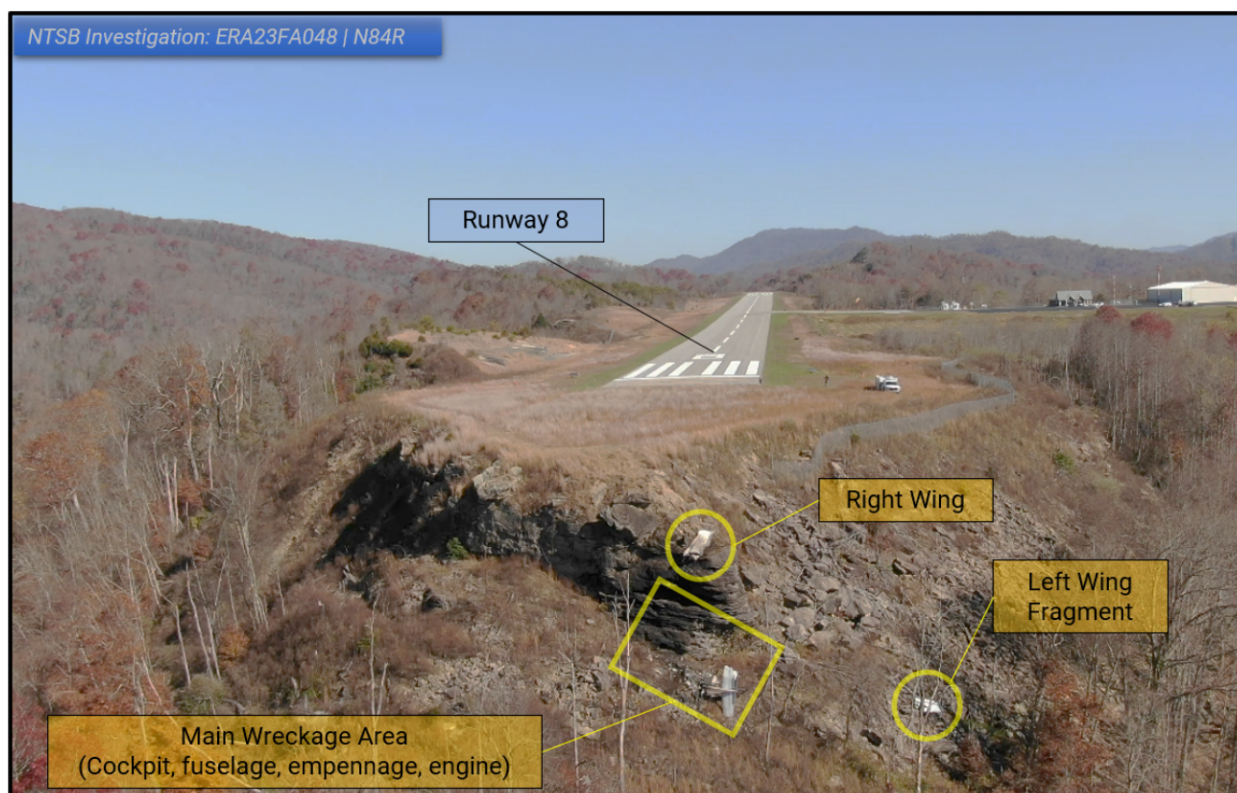
The airplane impacted a ravine and steep rock wall about 50 ft below and 375 ft before the runway 8 threshold. All major portions of the airframe were located, and a post-crash fire consumed a majority of the cockpit, fuselage, and portions of the left wing. Figure 3 depicts a drone image showing the view of the final approach to runway 8 and the disposition of the wreckage.

Figure 2: Drone image providing an overview of the approach to runway 8 and the disposition of the wreckage (Photo Courtesy of Kentucky State Police)
